TAILINGS MANAGEMENT AT HECLA

Tailings Stewardship Program

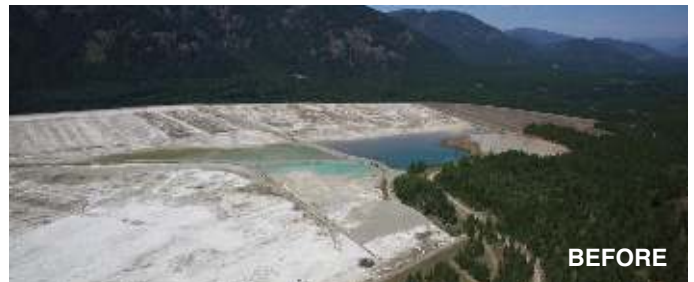
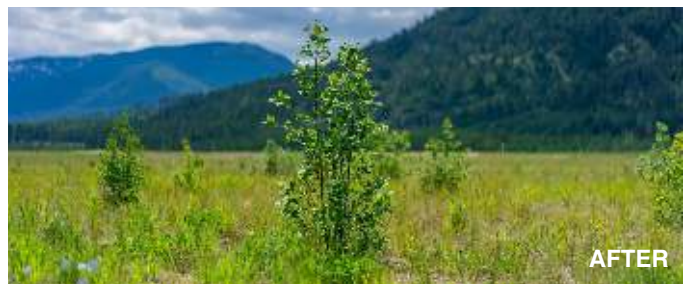
TROY RECLAMATION

A. Before we begin, we think of the finish. The initial tailings design process includes planning for final reclamation and closure of our tailings facilities. However, we perform concurrent reclamation where feasible. For example, we have closed two older facilities and are in the process of closing a third facility at the Lucky Friday Mine in Idaho. Also, the tailings facility at Grouse Creek in Idaho is no longer considered a jurisdictional dam, has been reclaimed, and the financial assurances released. At the Troy Mine in Montana, we have reclaimed the 300-acre tailings storage facility by placing soil cover and revegetating the surface to return the land to productive post-mining uses. We have planted more than 200,000 shrubs and trees that are already creating a self-sustaining native forest community and wildlife habitat.
